Unannounced Onsite Observations of School Bus Safety Devices

Report #2022-01

SUBJECT: September 27, 2021, Unannounced Onsite Observations of School Bus Safety Devices

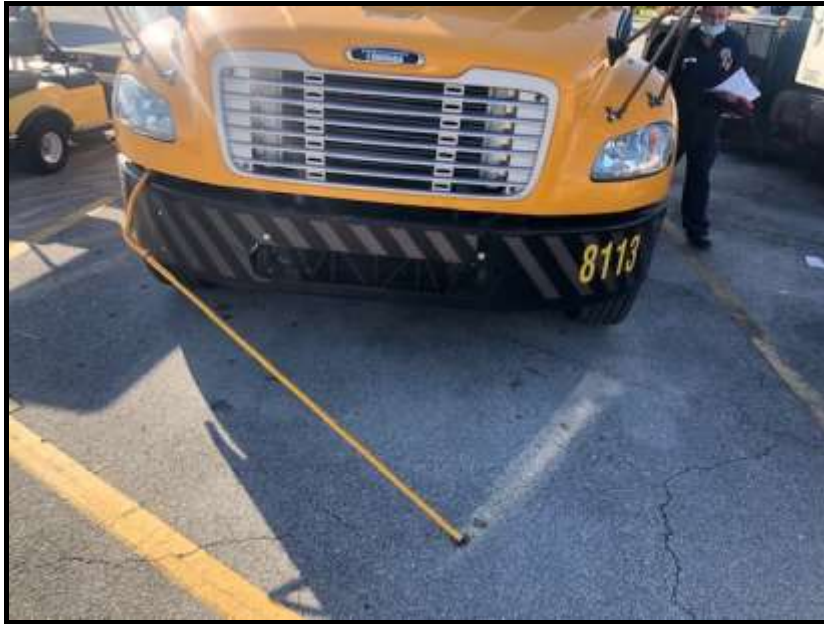
Crossing Arms Not Fully Deploying. On four buses, the Student Crossing Arm did not fully deploy to perpendicular to the front bumper as required by the FDOE's *Florida School Bus Specifications, eff. January 2020*. Three arms extended only one-half the required distance and one extended three-fourths. (See Photo #1 and Photo #2 at page 5.)

Examples of Student Crossing Arms Not Fully Deployed

OIG Observation Results Provided to Staff for Immediate Corrective Actions. To ensure the safety of all students and employees, the OIG provided all observation results to the Maintenance Foreperson of each compound for immediate corrective actions during the September 27, 2021, on-site observations. At the East compound, the non-working camera was fixed by a technician during the OIG's visit.

Transportation should ensure: (1) all safety devices are in proper operational condition when the buses are transporting students, and (2) bus drivers are properly performing the required pre- and post-trip inspections and documenting their inspection results on the *Bus Driver and Attendant Pre/Post-trip Inspection Report (PBSD 0454)*.
